STRUCTURAL

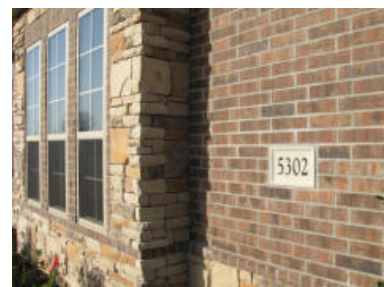
Good - The exterior siding material was in good condition. **Attention Needed** - Because this home is of new construction, you should monitor the siding during the first 2 to 3 years. Most homes do settle to some point within the first 2 years of construction. Conditions could develop that would require repairs. Weep holes I did not note the presence of weep holes. After construction, it would not be practical to install weep holes. This is a code issue.

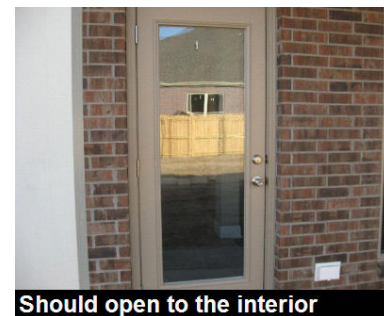
Action Necessary - The rear entry door opens to the exterior. This is not recommended. You may desire to have another door installed that opens to the interior.

Should open to the interior

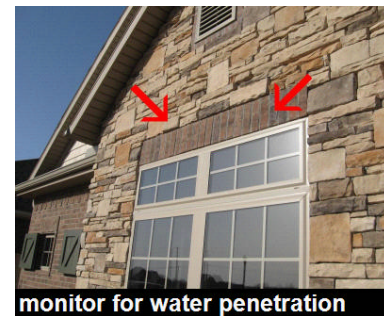
Good - The windows in this structure were in good condition at the time of this inspection. **Attention Needed** - I did have a area of concern on the front of the homes left window. there is no overhang to the window. If the window is not properly flashed, water penetration could occur. Most flashing is not visible, I only inspect items that are visible. see picture. Also it is recommended that the lintels (headers) over the windows be painted to prevent rusting.

monitor for water penetration
