ATTIC AND ROOF FRAMING

SECTION 4

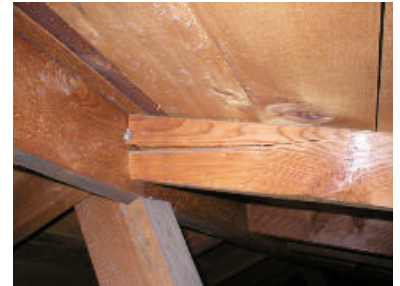
406 ROOF FRAMING	The visible areas of the roof framing appeared functional.
407 ROOF RAFTER(S)	[FE] Rafters are split/cracked/damaged.
