# HOME STRUCTURE REPORT

568 DANFORTH AVE., TORONTO.

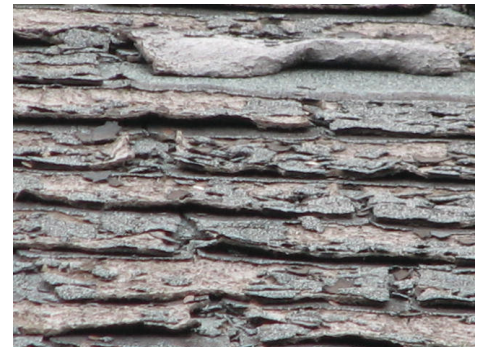
**Roof Life Expectancy:** The roof surface appears to be at or very near the end of its useful life and will subsequently fail to protect the building from water damage.

- Replace missing shingles
- Secure and reseal loose flashing
- Repair ridge caps
