REPORT OF MARINE SURVEY

PRE-PURCHASE CONDITION & VALUE
of the vessel

1998 Sea Ray 33' Sundancer 330

Bob Ptak, AMS #842 - S.A.M.S.
Society of Accredited Marine Surveyors
on
8/26/2010

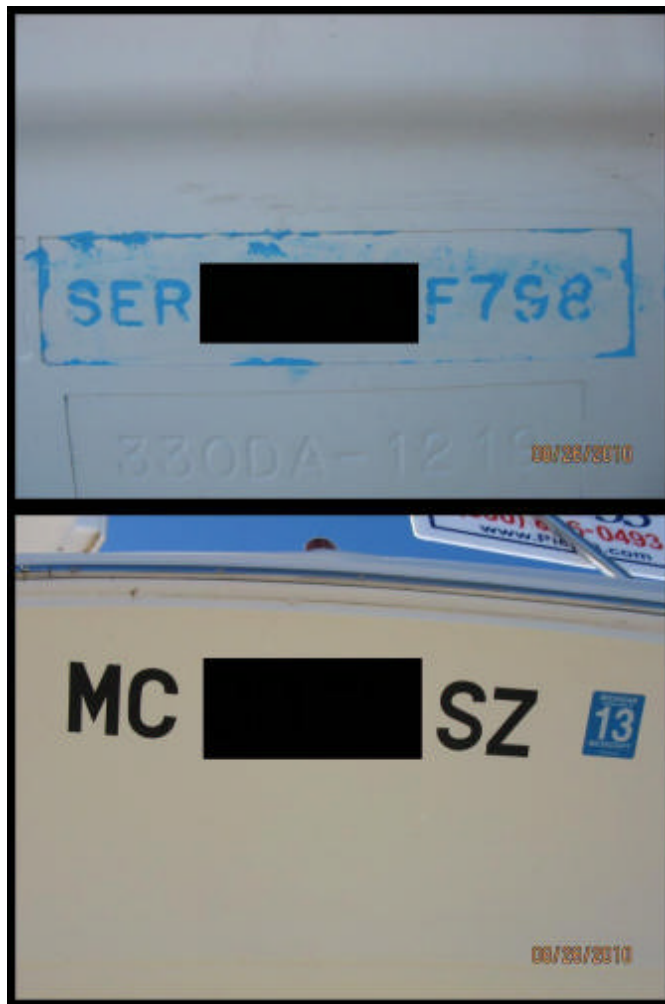
Hull ID number (HIN): SER____F798 - A true digital photograph of the hull ID number of the referenced vessel is shown here. HIN was pencil/chalk enhanced to show more clearly.

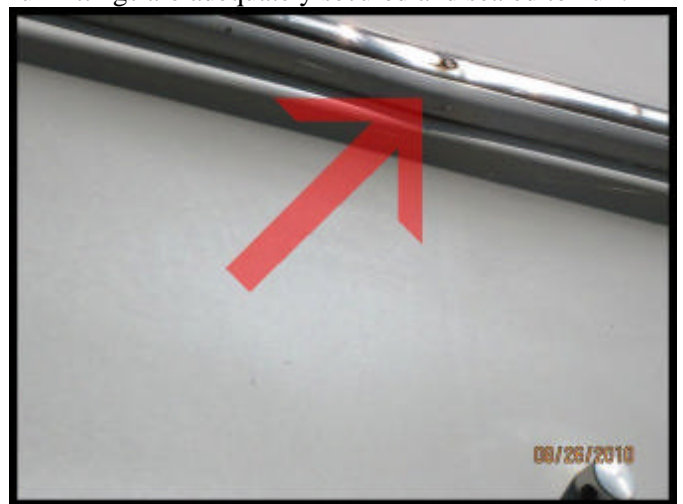
Rub rail:

Rub rail is stainless steel with backing of white plastic. Well secured in good condition with only minor scrapes. An area on the starboard side shows a flattened portion of stainless steel rail but all remain serviceable.

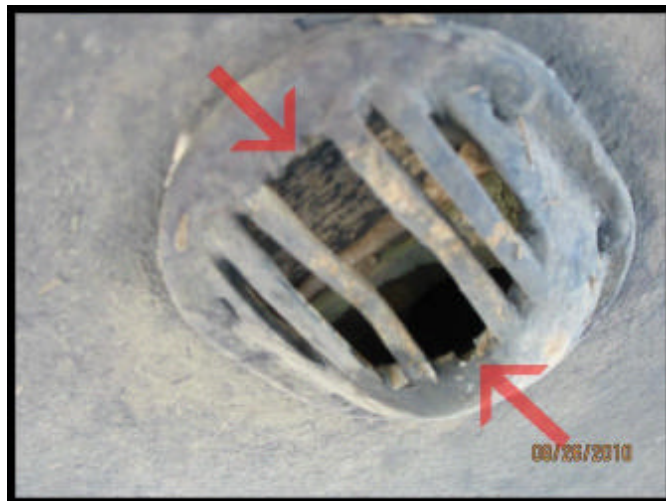
Strainers/Scoops/Screens:

All strainers/screens are well secured to hull bottom. Clear of debris & zebra mussels. **Port side strainer is bent and one vane is missing but remains serviceable. Replace as desired.**

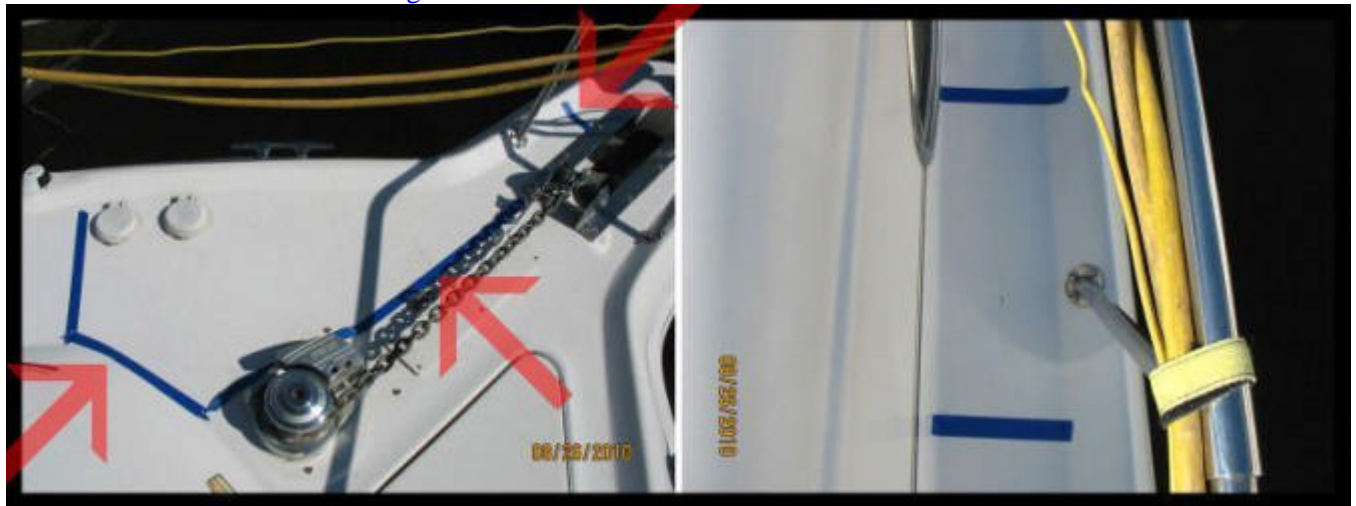
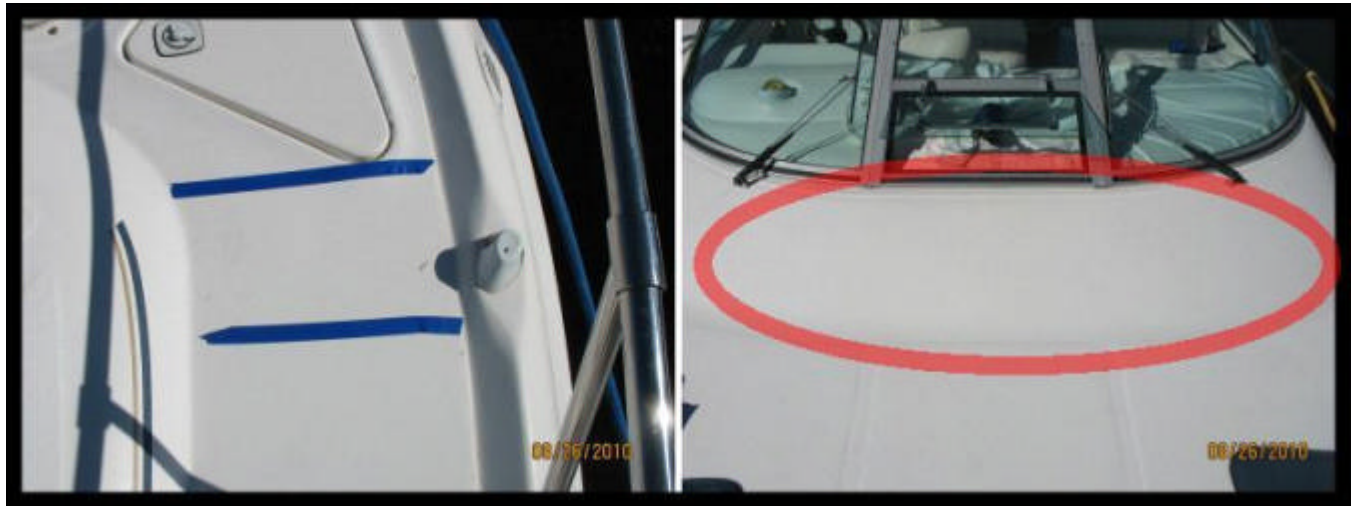
Most of the top deck had normal relatively Dry moisture meter readings. Higher than normal moisture readings found in deck surface as follows: (Most marked with tape for clarity or use of arrows/circles on photo)

- 1) Foredeck area near windlass
- 2) Near anchor locker
- 3) Port side near port light and stainless steel rail support
- 4) Slanted area in front of windshield.

Percussion hammer used to test deck surface and no apparent delamination was found in any high moisture areas. Deck is not spongy or soft and is solid under foot. It is not unusual to discover some deck moisture in older vessels.

RECOMMENDATION: To seal off deck from further moisture penetration, deck fittings near elevated moisture areas should be removed and resealed.

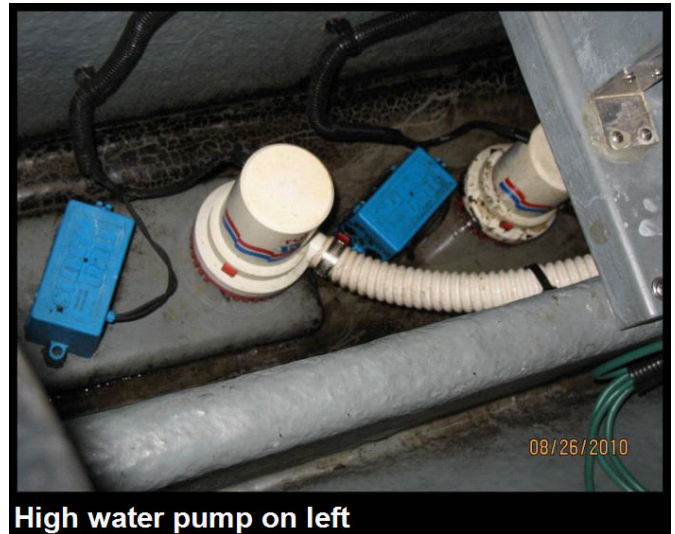
High water pump on left

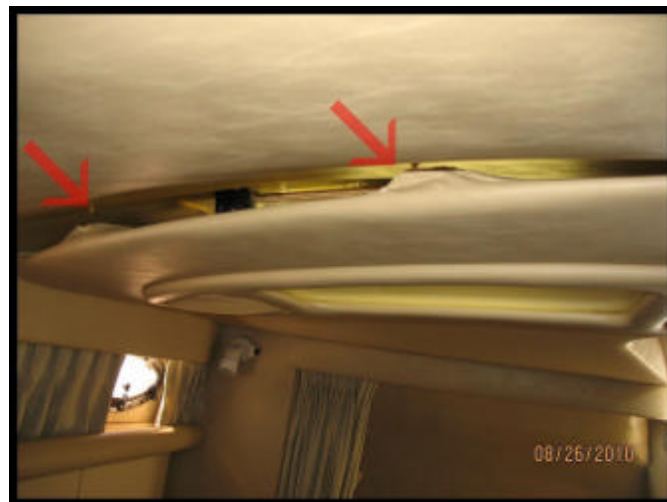
Headliner: Soft padded vinyl. Clean. No tears, splits or stains sighted. **The headliner on the starboard side in main cabin area is not well secured to top deck. RECOMMENDATION: Secure headliner to cabin top.**

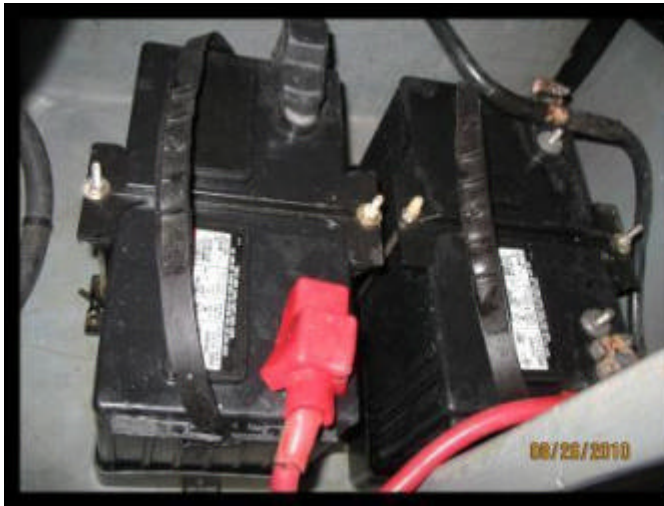
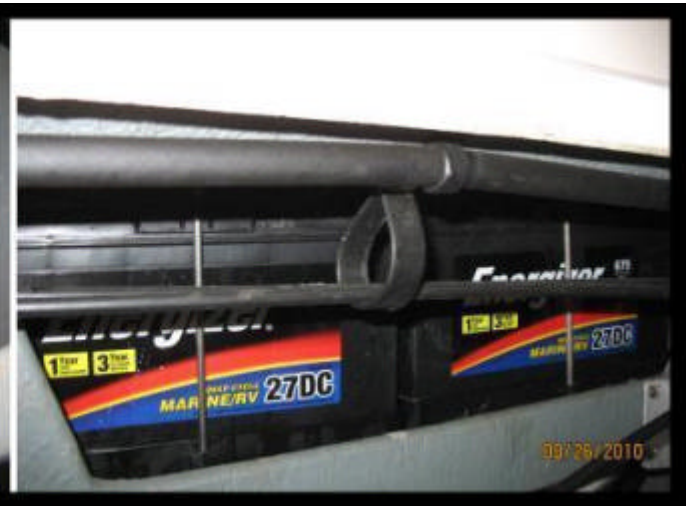
Primary batteries: There are four batteries (two sets of two) located in the engine compartment that are Group 27 Lead acid which provide service to the main engines, generator and house. Each set of two are wired in parallel producing 12 volts. Batteries are well secured in boxes with straps or hold down brackets. Cables are properly color coded and positive terminals are properly covered with boots or box covers.

Battery selector switch: Not equipped. RECOMMENDATION: ABYC E-11.7 recommends a battery switch be installed for each battery or bank with a CCA rating of 800 Amps. Recommend compliance for safety reasons.

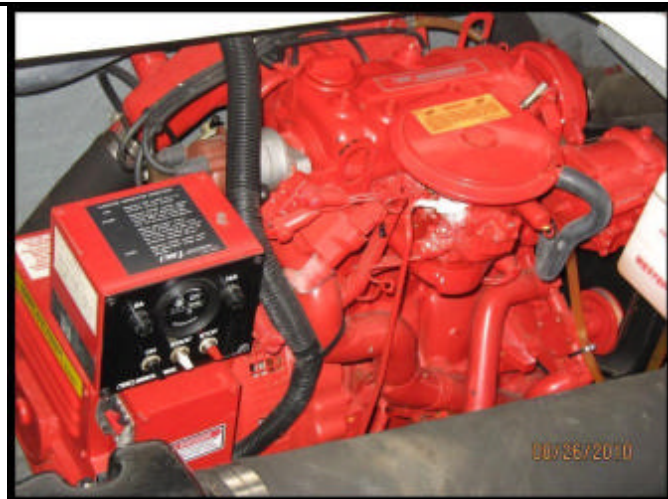
Type & Size:	Gasoline powered, Three cylinders.
Serial number:	Tag not readable.
Kilowatt/Voltage rating:	120 Volts AC, Kilowatt rating could not be read off label.
Hour meter:	Meter reads 41.5 hrs.
Generator test:	The generator started without any excess cranking and rapidly came up to speed. Generator maintained voltage when loaded with all AC units running as well as other AC electrical components.
Type of installation:	On tray.
Hoses and clamps:	Properly double clamped.
Belts and pulleys:	Belts condition are serviceable. No cracks or splits sighted. Pulleys/belts appear to be in line.
Cooling system(s):	Fresh water / heat exchanger cooled with water intake through lever action seacock.

Coolant level low in tank for generator. ----- Top off coolant reservoir and monitor frequently for leaks.

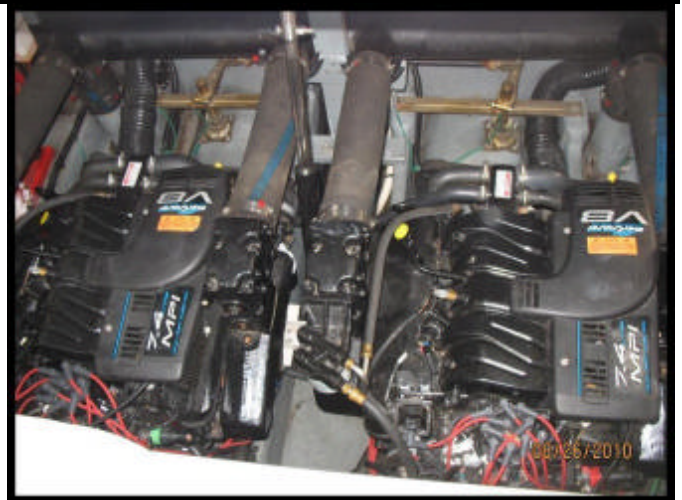
Serial no(s): Port engine: Tag not sighted on engine. Starboard engine: 0L00 ____.
Engine(s) hours: Port: 491.5 Starboard: 498.2.
Raw water hoses: Good condition-No cracks, soft spots or leakage sighted.
Belts and pulleys: Belts condition are serviceable. No cracks or splits sighted. Pulleys/belts appear to be in line.
Cooling system(s): Raw water cooled, Raw water strainer(s) installed and clear.
Oil level and condition: Clean & full on dipstick(s). No evidence of water or cuttings in lube oil as sighted on dipstick(s).
Flame arrestor(s): Yes- USCG approved.
Ignition protection: Yes -Alternator and Starter are OEM and ignition protected.
Engine ventilation: Natural ventilation for engine space is provided. Power exhaust ventilation blower(s) are installed. Power vents are fully operational.

Drip pad(s) : No Pads in place beneath engine(s). Fluids and debris fall into bilge area. ----- Consider installing drip pads beneath engine(s) to catch fluid drippings and rapidly identify leaks of any kind.
