456 Castle Avenue, Laguna Beach, CA 92651

**INSPECTION FOR:** Ms. Mary Brown  
**REAL ESTATE COMPANY:** Laguna Properties  
**REAL ESTATE AGENT:** Robert McLennan

**INSPECTION DATE:** 04/18/2012

**PREPARED BY:** Bruce R. White, Owner/Chief Building Inspector

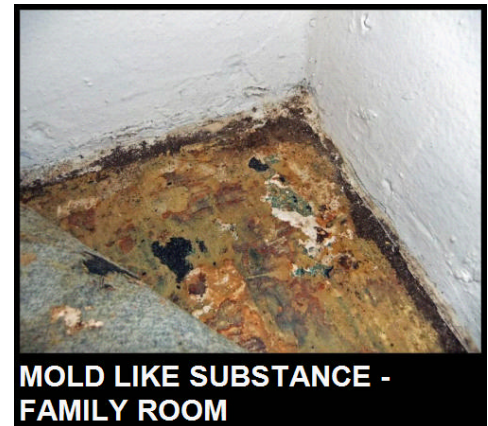
**ACTION ITEM:** Mold like substance noted at the family room right wall/floor. Recommend further review by an Industrial Hygienist to determine the cause of mold, the type of mold or whether the mold might pose any risk to the property or its inhabitants. Remediation needed. For more information, please refer to the General Report Limitations - Mold.

**MOLD LIKE SUBSTANCE - FAMILY ROOM**

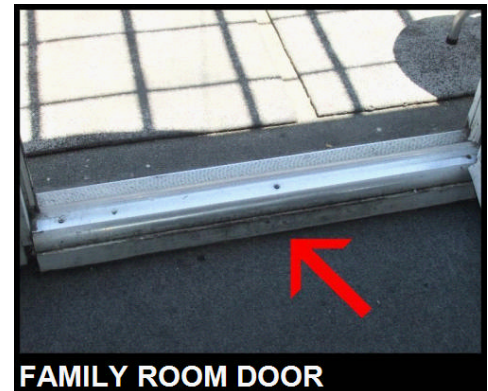
**ACTION ITEM:** Door opens inward with the interior landing level exceeding the building standards. The interior landing level shall not be more than 1.5 inch lower than the door threshold. This condition could represent a Trip and Fall Hazard. Recommend correction by a qualified professional or exercise caution when using.

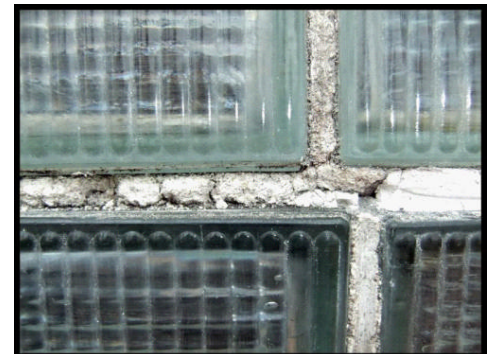
**MAINTENANCE ITEM:** Window items that need service or repair. Grout deteriorated and missing at the glass block windows. This condition could lead to water intrusion problems. Have a qualified professional make proper repairs as needed. Refer this condition to the Homeowners Association.

**GROUT  
DETERIORATED/MISSING**

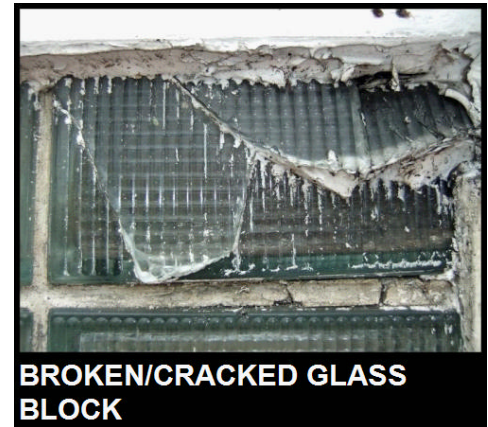
**ACTION ITEM:** Several cracked/broken glass blocks. Recommend correction by a qualified professional. Refer this condition to the Homeowners Association.

**BROKEN/CRACKED GLASS  
BLOCK**

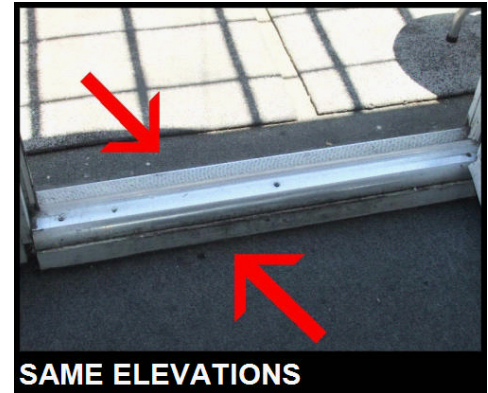
**ACTION ITEM:** The elevations between the exterior and interior floors are at similar elevations. Such conditions are obviously not ideal, and moisture intrusion could result. Recommend further review with the seller to determine if the living area/ areas has or has had any water intrusion problems. Suggest monitoring during heavy rains. Refer this condition to the Homeowners Association.

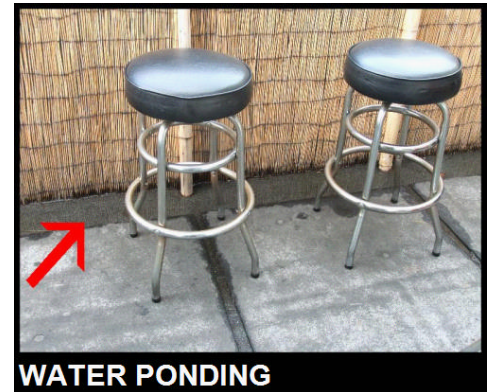
**ACTION ITEM:** Evidence of water ponding at the deck. This condition will lead to premature failure of the deck covering. Recommend further review and correction by a qualified professional. Refer this condition to the Homeowners Association.

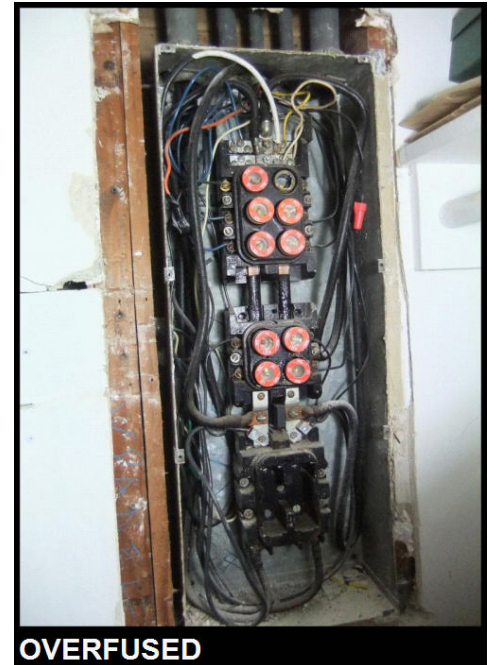
**ACTION ITEMS:** Electrical circuitry wiring in the secondary panel shows some condition that calls for action of a qualified licensed Electrical contractor.

1. Fuses are not labeled as to the rooms, areas, or appliances controlled. Accurate labeling allows individuals unfamiliar with the equipment to operate it. It is recommended that they be labeled as soon as possible.
2. Wiring is undersized for fuse size. Oversized fuses will not shut off the electricity when the current levels become dangerous. This creates a fire hazard and should be corrected.

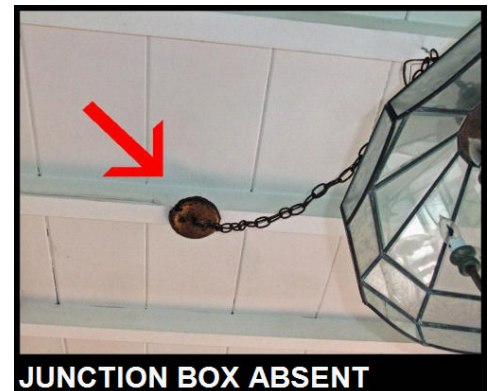
**ACTION ITEM:** Junction box not installed/absent at the pendant light fixture. Junction boxes are required to protect the wiring connections. Lack of junction boxes is a fire hazard. Recommend correction by a qualified licensed Electrical contractor.

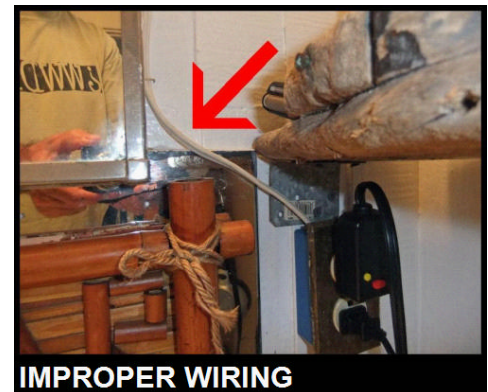
**ACTION ITEM:** Lamp cord wiring being used in place of permanent wiring. Lamp cords are not appropriate for use in permanent installations, are easy to overload, and are easily damaged, which could create a shock or fire hazard. Removal of all installed lamp cords and replacement with appropriate, permanent wiring is recommended. Recommend correction by a qualified licensed Electrical contractor.

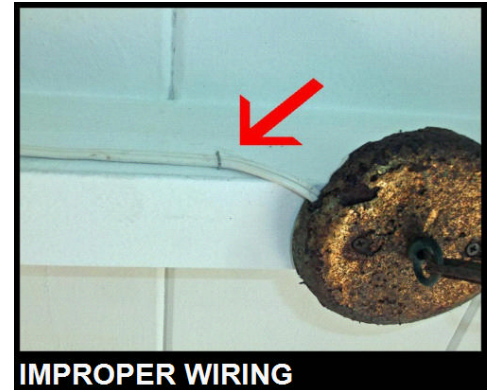
**ACTION ITEM:** Lamp cord and extension cords are being used in place of permanent wiring. Lamp cord and extension cords are not appropriate for use in permanent installations, are easy to overload, and are easily damaged, which could create a shock or fire hazard. Removal of all installed lamp and extension cords and replacement with appropriate, permanent wiring is recommended. Recommend correction by a qualified licensed Electrical contractor.

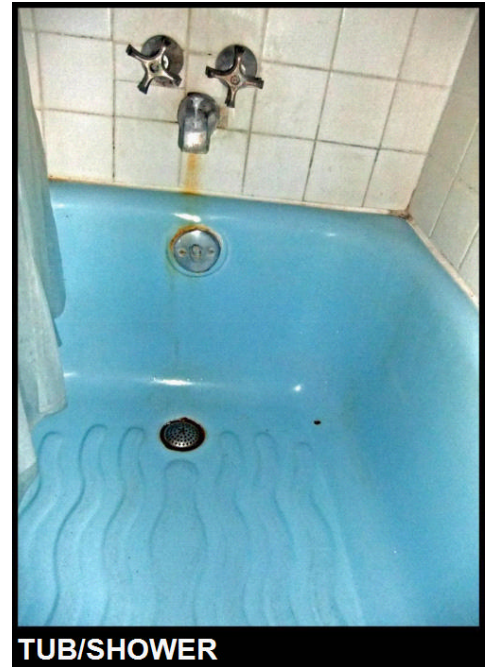
**MAINTENANCE ITEM:** Tub/shower faucet fixtures that need service or repair. Tub to shower water diverter inoperative - failed to divert the water to the tub spout. Corrosion noted to the faucet fixtures. Although there is currently no leak, expect replacement in the future. Have a qualified licensed Plumbing contractor make proper repairs as needed.

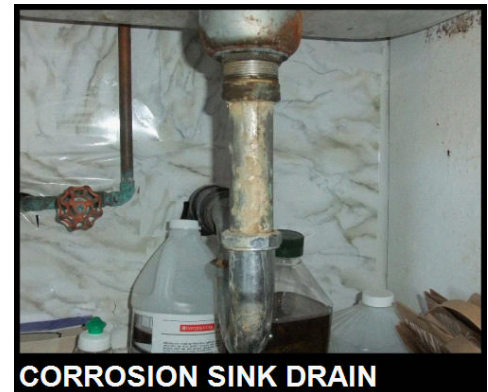
9.11 SINK DRAIN **MAINTENANCE ITEM:** Sink items that need service or repair. Corrosion and evidence of past leakage noted to the drain pipes under the sink. Although there is currently no leak, expect replacement in the future. Have a qualified licensed Plumbing contractor make proper repairs as needed.

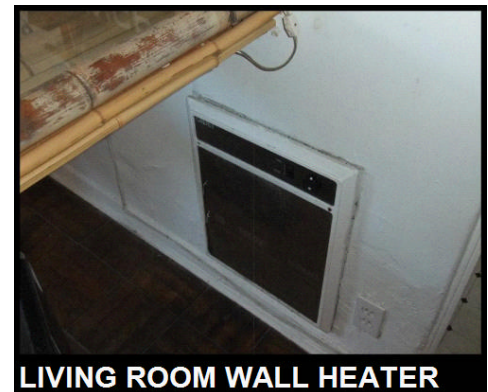
24 years. The wall heater appears to be at or near the end of its economic life. Although it is functional today, you should budget for future replacement. Suggest purchase and maintaining a home warranty policy on this unit.

**LIVING ROOM WALL HEATER**

Recommend asking seller when the heater was last serviced. If unable to determine or if more than one year ago, recommend routine safety inspection and servicing by a licensed Heating and Air Conditioning contractor. Recommend that this servicing be made annually in the future or as recommended by the technician.

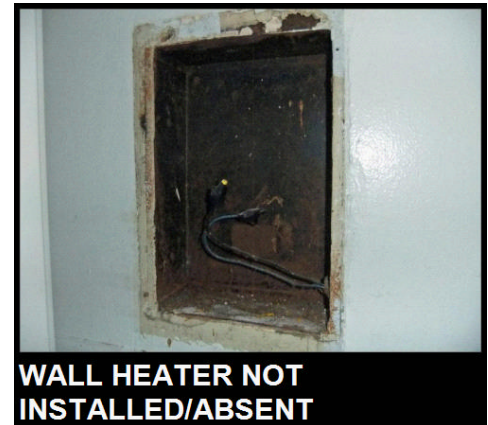
- 13.3 OBSERVATION **ACTION ITEM:** Wall heater not installed/absent. Recommend installation by a licensed Heating and Air Conditioning contractor.

**WALL HEATER NOT INSTALLED/ABSENT**

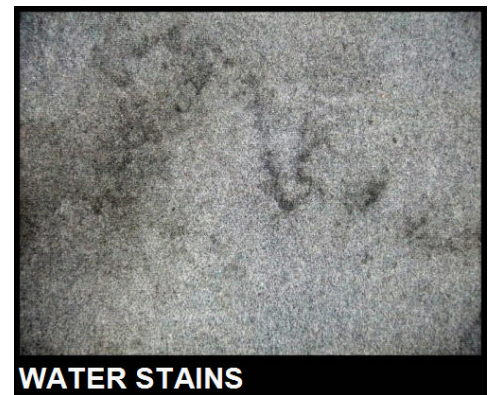
- 14.1 FAMILY ROOM **ACTION ITEM:** Evidence of past water intrusion with water stains and damage noted to the carpet by chimney. Recommend further review with the current owner to determine if this is an ongoing problem or an isolated incident. Verify any remedial work completed that eliminated the condition.

**WATER STAINS**

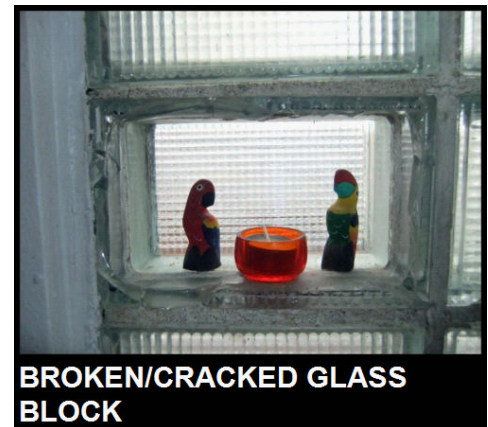
**ACTION ITEM:** Several cracked/broken window glass blocks. Recommend a qualified professional make proper repairs.

**BROKEN/CRACKED GLASS BLOCK**

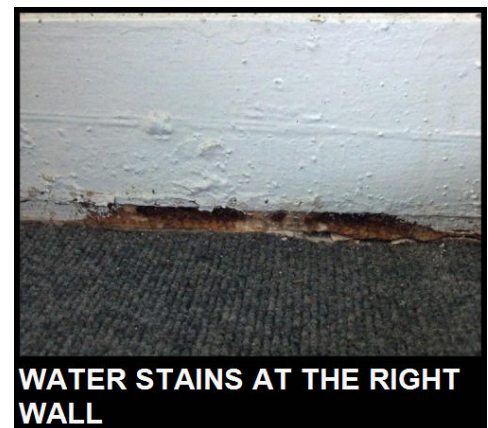
**ACTION ITEM:** Evidence of water intrusion with water stains and damage noted to the right wall. This is an active leak - elevated levels of moisture detected with a moisture meter. Recommend further review with the current owner to determine if this is an ongoing problem or an isolated incident. Verify any remedial work completed that eliminated the condition.

**WATER STAINS AT THE RIGHT WALL**

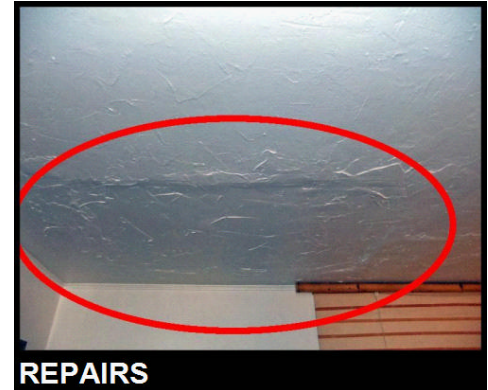
**ACTION ITEM:** There is some form of repairs made to a portion of the ceiling. Unable to determine the age of the repairs or the effectiveness of the repairs made. The repairs are described, but the inspector accepts no liability for the repairs or their effectiveness. It is strongly recommended that you investigate the source of the repairs made with the current owner prior to closing. If possible, determine who made the repairs and what warranty if any remains.

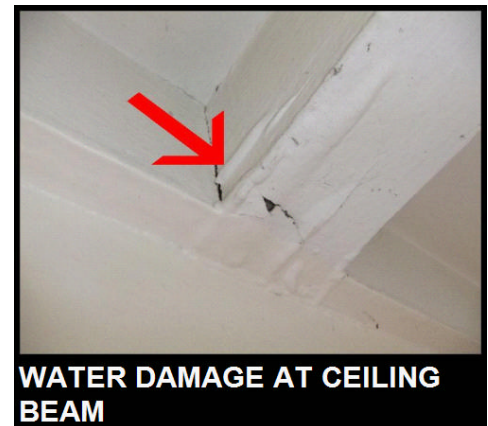
**ACTION ITEM:** Evidence of water intrusion with water stains and damage noted to the ceiling. This is an active roof leak - elevated levels of moisture detected with a moisture meter. Recommend further review with the current owner to determine if this is an ongoing problem or an isolated incident. Verify any remedial work completed that eliminated the condition.

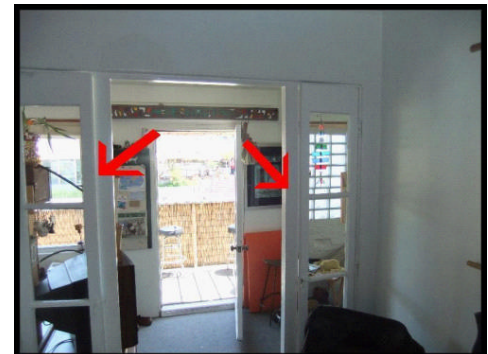
14.15 LIVING ROOM **SUGGESTED UPGRADE:** No visible safety glazing labels at the side light windows. This condition was permitted and standard at the time of construction - eventual upgrading may be desirable for additional safety.

**NON-TEMPERED GLASS - SIDE LIGHT WINDOWS**
