Confidential Inspection Report
999 Main St.
Fort Myers, FL 33903

Prepared by: 3D Inspection Systems, Inc.
3D Inspection Systems
Fort Myers, FL 33907
800-745-6126 info@3dinspection.com

GENERAL INFORMATION

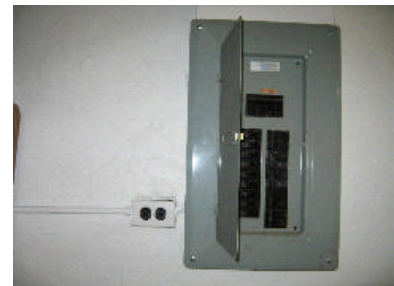
Electrical Distribution Panels:

p	Main Panel Location: Garage, Appears serviceable.
			Main Panel Observations: Circuit and wire sizing correct so far as visible, Grounding system is present, Multiple wires are connected to a single lug on a circuit breaker where only one wire should be connected, Missing strain relief at panel, Have a licensed electrician make further evaluation and corrections as needed.
			110 Volt Circuits: 12.
			220 Volt Circuits: 6.
p	Subpanel #1: Located in the Air conditioner.
p	Subpanel #2: Located in the Utility room.

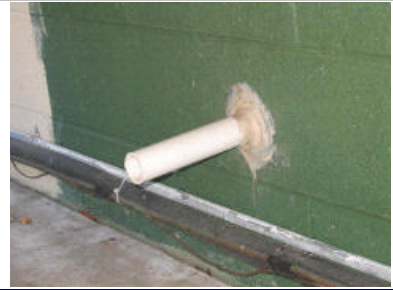
Laundry:

There is no trap on the drain line. Drain line empties into the rear yard and is considered a sanitary nuisance by local officials. Consider connecting this drain lin to the main drain system serving the house.

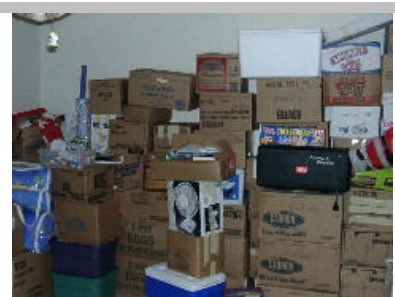
Closets:

<i>Kitchen Interior:</i>	Due to stored items in the closet, it is not possible to determine the condition of the walls and the ceiling that are not visible.
--------------------------	---

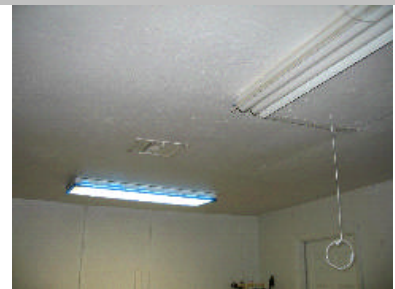
Ceilings:

Condition: Blemishes noted. Cosmetic repairs and trim needed to improve appearance.

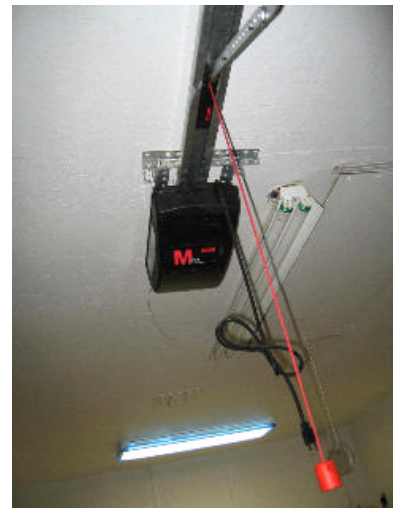
Garage Door:

Material - Condition: New door, metal with storm strapping.

Door Operator: Automatic door opener(s)- not operational, due to a lack of power. An electrical outlet should be installed in the ceiling.
