Confidential Inspection Report
999 Main St.
Fort Myers, FL 33903

Prepared by: 3D Inspection Systems, Inc.
3D Inspection Systems
Fort Myers, FL 33907
800-745-6126 info@3dinspection.com

GENERAL INFORMATION

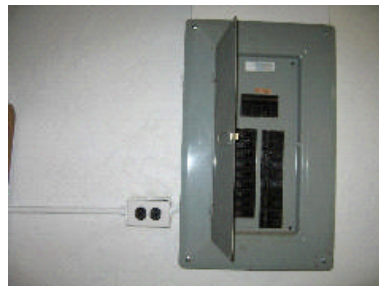
p	Main Panel Location: Garage, Appears serviceable.
			Main Panel Observations: Circuit and wire sizing correct so far as visible, Grounding system is present, Multiple wires are connected to a single lug on a circuit breaker where only one wire should be connected, Missing strain relief at panel, Have a licensed electrician make further evaluation and corrections as needed.
			110 Volt Circuits: 12.
			220 Volt Circuits: 6.
p	Subpanel #1: Located in the Air conditioner.
p	Subpanel #2: Located in the Utility room.

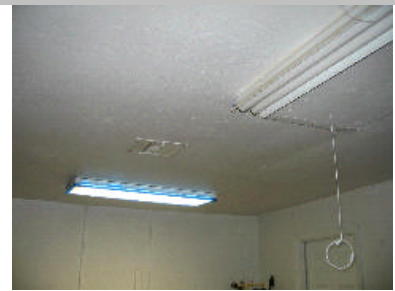
Ceilings:

Condition: Blemishes noted. Cosmetic repairs and trim needed to improve appearance.

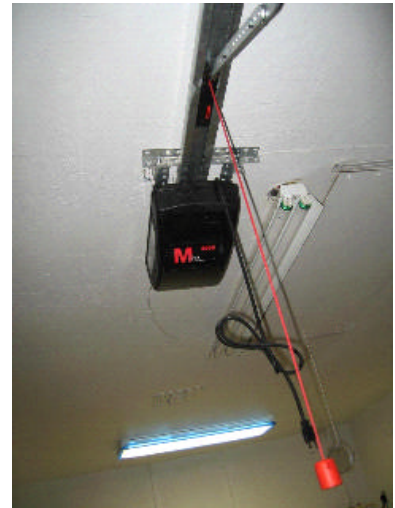
Door Operator: Automatic door opener(s)- not operational, due to a lack of power. An electrical outlet should be installed in the ceiling.
