STRUCTURAL

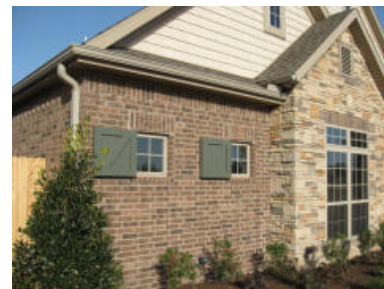
Combination of: Brick. Vinyl Siding. Stone.

Good - The exterior siding material was in good condition. **Attention Needed** - Because this home is of new construction, you should monitor the siding during the first 2 to 3 years. Most homes do settle to some point within the first 2 years of construction. Conditions could develop that would require repairs. Weep holes I did not note the presence of weep holes. After construction, it would not be practical to install weep holes. This is a code issue.
