# HOME STRUCTURE REPORT

568 DANFORTH AVE., TORONTO.

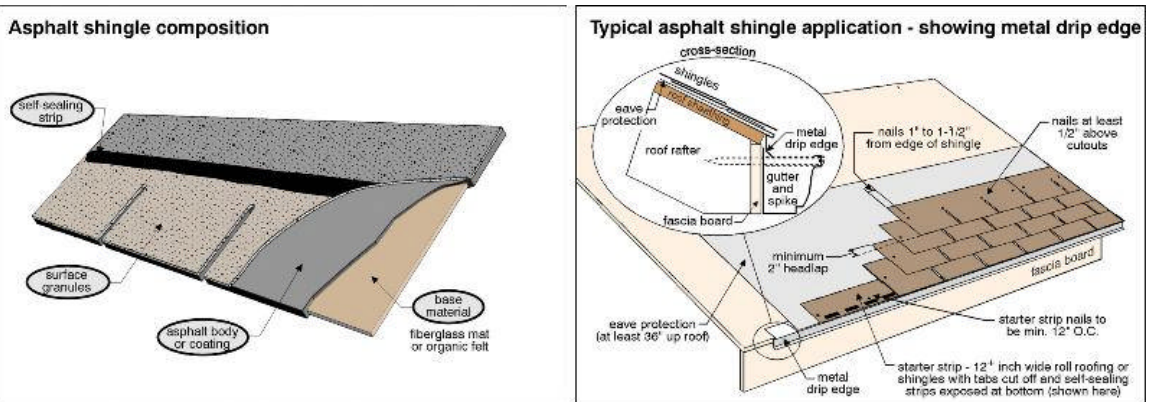
*Slope - Hip, Surface Material - Asphalt Shingle.*

**Roof Surface Age:** Approximately 15-20 Years.

**Roof Life Expectancy:** The roof surface appears to be at or very near the end of its useful life and will subsequently fail to protect the building from water damage.

- Replace missing shingles
- Secure and reseal loose flashing
- Repair ridge caps
