REPORT OF MARINE SURVEY

PRE-PURCHASE CONDITION & VALUE
of the vessel

1998 Sea Ray 33' Sundancer 330

Bob Ptak, AMS #842 - S.A.M.S.
Society of Accredited Marine Surveyors
on
8/26/2010

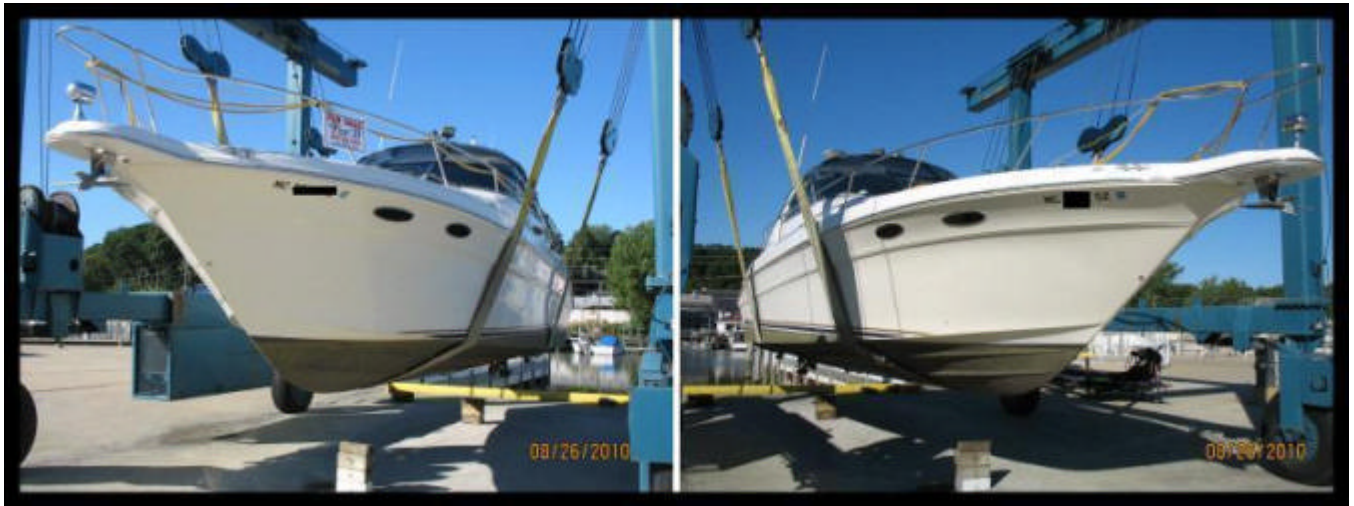
HULL EXTERIOR-SIDES

Hull cosmetics are in good condition-minor nicks and scratches which are typical for a vessel of this age.

All moisture meter readings on side hull near the water line and surrounding thru hull fittings were relatively dry with normal comparative moisture meter readings.

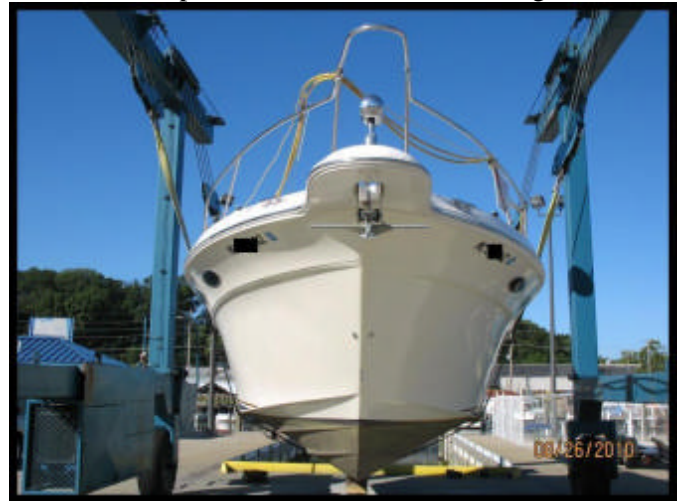
Stem:

Moderate flare- Solid, no cracks on external inspection. Moisture readings relatively Dry.

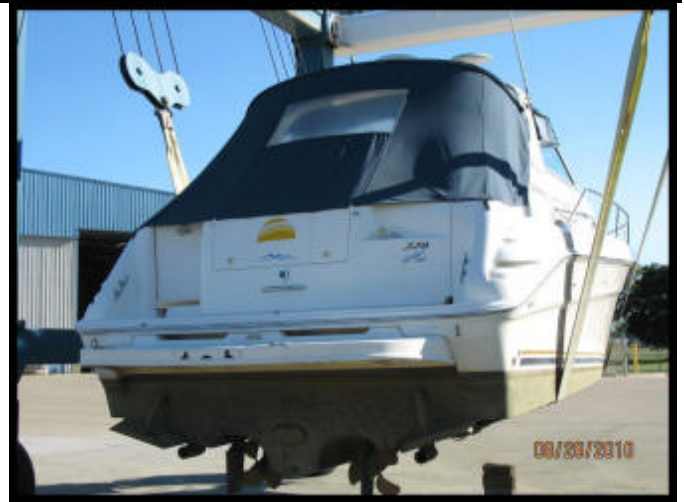
TRANSOM

Transom type: Conventional transom, and an attached swim platform. Well secured, no cracks or defects sighted.

Moisture/Delamination: All moisture meter readings on transom and surrounding thru hull fittings were relatively dry with normal comparative moisture meter readings.

Stress cracks: None sighted.

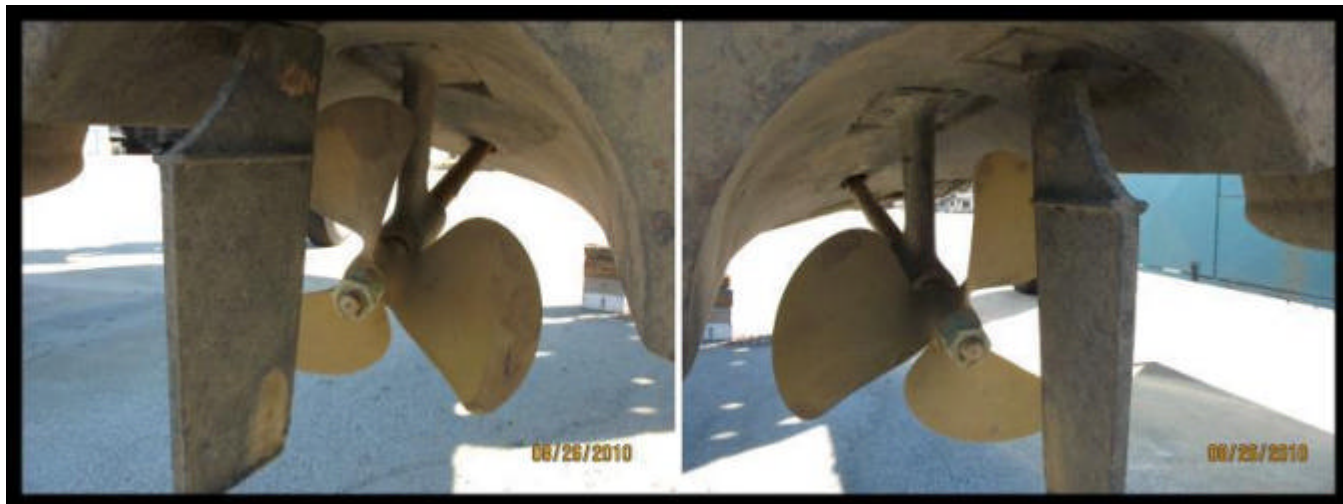
Prop(s) description:

Props have three blades and are made of bronze alloy with a diameter and pitch of 17 X 17. Port is LH Starboard is RH. Props are in excellent condition. No bent, chipped or damaged prop blades. Prop nuts are secure and properly locked in place with jam nut and properly cotter pinned.

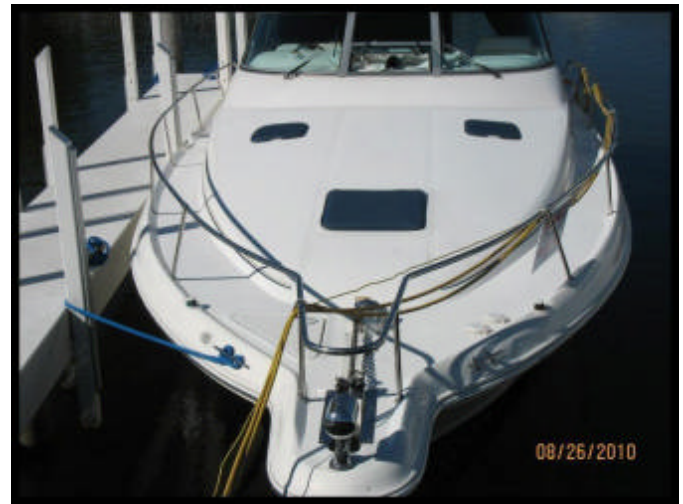
Deck Surface:

Molded, cored fiberglass deck construction (core not sampled). White gel coat with molded in non skid fiberglass surface. Good condition. Deck is solid under foot, no soft spots discovered and no visible cracks or chips sighted.

Most of the top deck had normal relatively Dry moisture meter readings. Higher than normal moisture readings found in deck surface as follows: (Most marked with tape for clarity or use of arrows/circles on photo)

- 1) Foredeck area near windlass
- 2) Near anchor locker
- 3) Port side near port light and stainless steel rail support
- 4) Slanted area in front of windshield.

Percussion hammer used to test deck surface and no apparent delamination was found in any high moisture areas. Deck is not spongy or soft and is solid under foot. It is not unusual to discover some deck moisture in older vessels.

RECOMMENDATION: To seal off deck from further moisture penetration, deck fittings near elevated moisture areas should be removed and resealed.

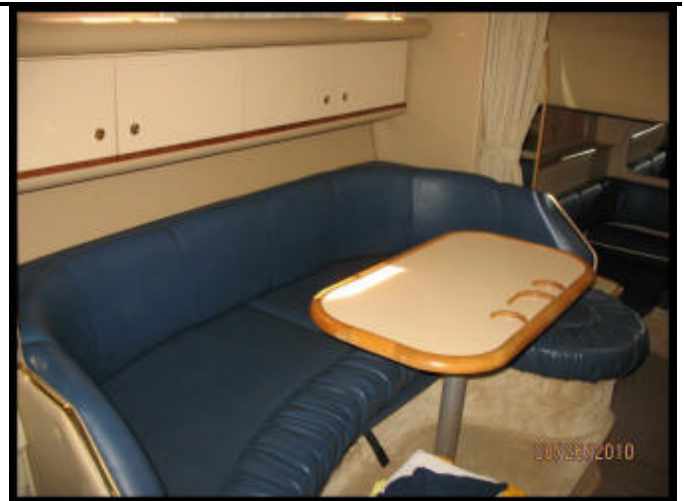
MAIN SALON

Cabin steps: Carpeted cabin entrance steps.
Sole: Carpeting installed throughout with snap down carpet protectors.
Bulkheads/Trim: Padded soft vinyl covered. Clean and unmarred.

Headliner: Soft padded vinyl. Clean. No tears, splits or stains sighted. **The headliner on the starboard side in main cabin area is not well secured to top deck. RECOMMENDATION: Secure headliner to cabin top.**

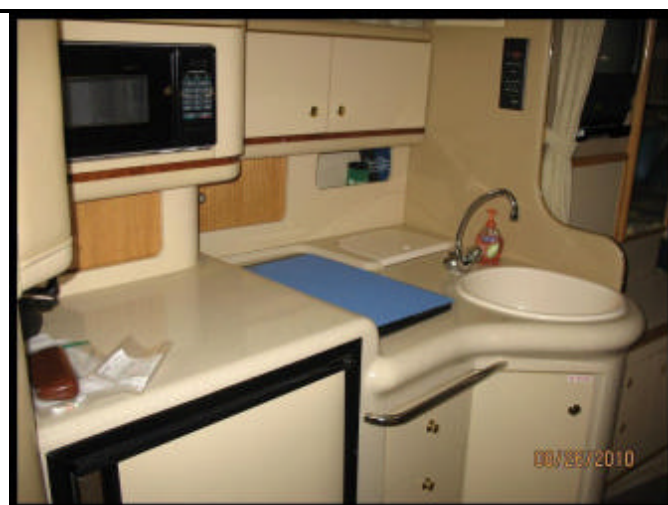
GALLEY

Location: Port side, with solid surface counter top.

Stove: Kenyon, two burner, alcohol/electric. Electric burners tested and are functional. Alcohol function not tested. Power indicator lights are functional. **Safety switch is functional but sticks in down position.---- Switch may need some light lube so it comes up when glass top cover is raised.**

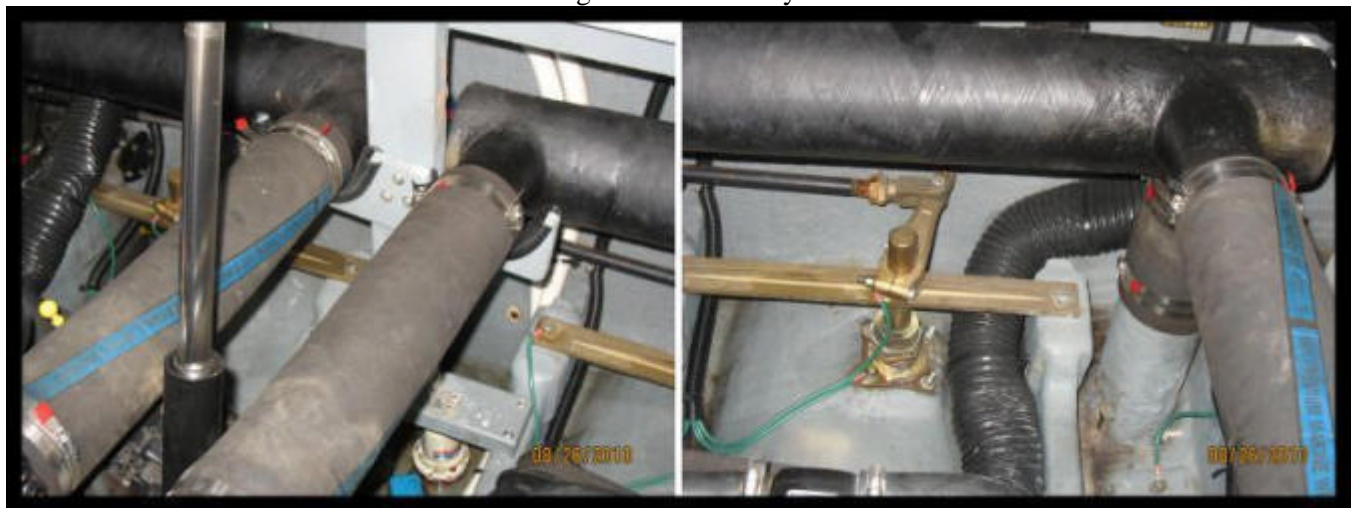
Exhaust manifold: Excellent condition- No cracks or leakage sighted using inspection mirror.

Piping/Clamps: Fiberglass and flex hose, Securely double clamped as required. No cracks soft spots or evidence of leaks sighted in exhaust system.
